019/2021

**PULP & PAPER
ELBOW
ABRASION PROTECTION**

ABRASION PROTECTION
AUGUST, 2015

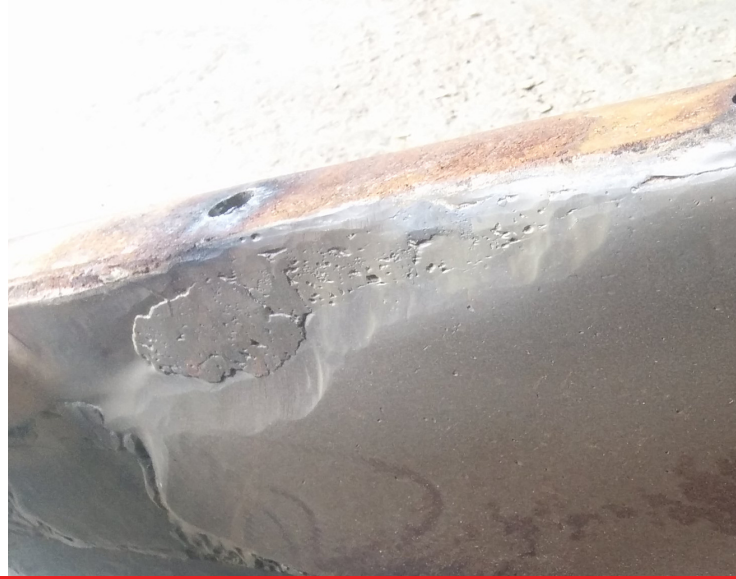
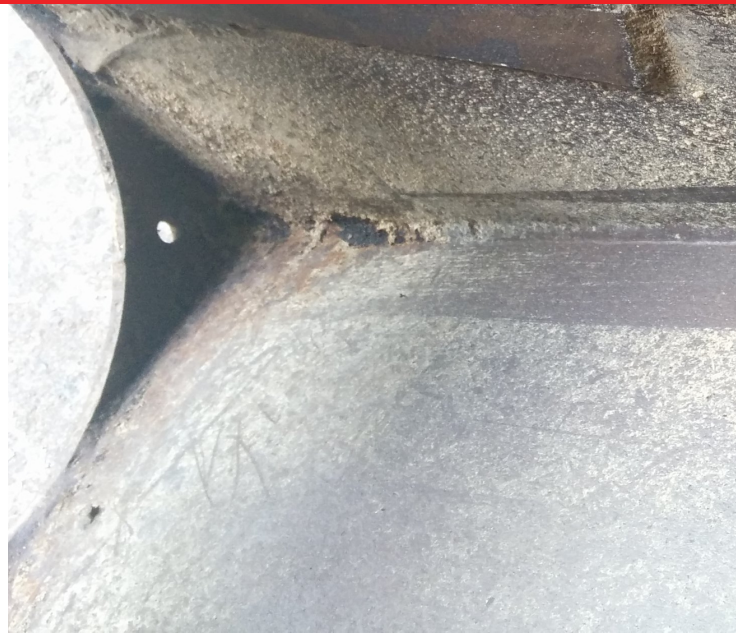
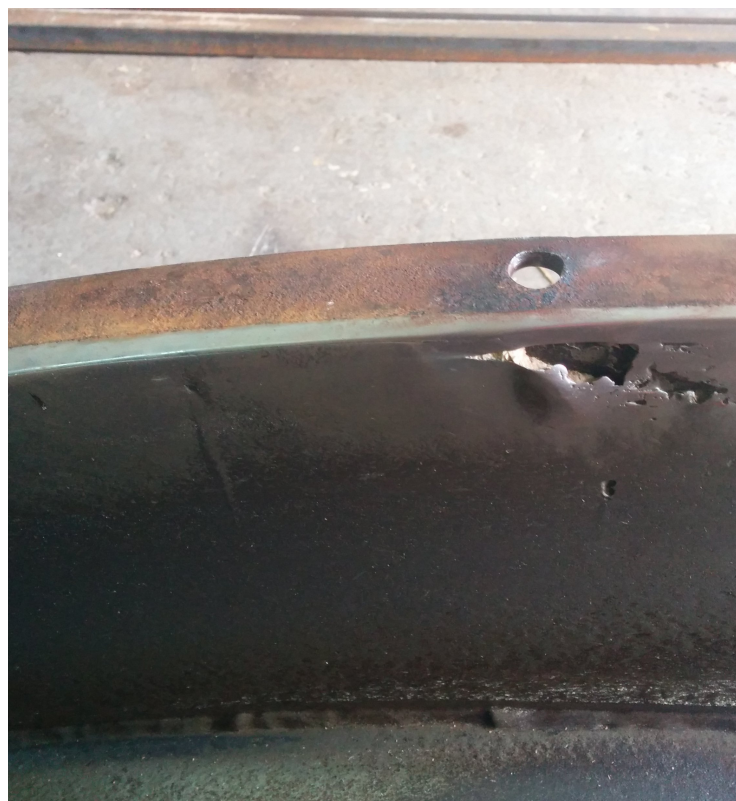
A customer in Northeastern Ontario was having issues with some of their elbows in their line. Blown wood particles had created loss of wall thickness due to abrasion, which eventually lead to blow-outs and loss of production.

The wood chips used to produce the particleboard at this facility are recycled. The wood chips, fibers and particles are moved around the facility and processed by mechanical and pneumatic means. Whenever there is a change of direction in the pneumatic system such as an elbow, it creates a wear point in the system.

The surface was prepared by initially grinding the steel to create a clean surface and then abraded with the MBX Bristle Blaster to create the correct surface profile. Belzona 1812 was applied to the wear areas of the elbow and the replaceable back, keeping within the designated wearing surfaces.

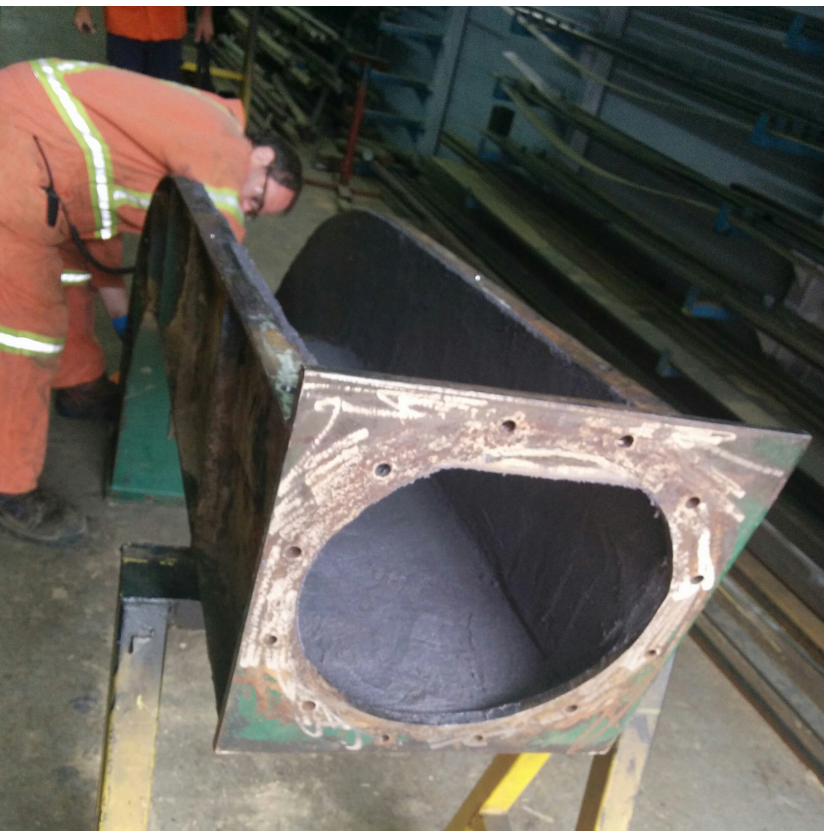
The product was applied at 1/4" thick with the use of a rigid applicator.

Belzona 1812 is a ceramic filled epoxy system designed to protect equipment surfaces exposed to severe abrasion. The product exhibits outstanding erosion resistance due to a hardness comparable to basalt. Belzona 1812 may be applied from 1/8" to unlimited thickness onto vertical or horizontal surfaces. Thicker applications will provide extended protection.
